## Trip Report for Technical Support of PreKoted E-3 Aircraft

- Inspection of PreKoted E-3 Tail # 80-0137
- Support E-3 SPO with removal of OML coating system with DeKote-AF on E-3 processed with PreKote Surface Pretreatment in 2005 with 2 step application process
- This is the second E-3 treated with PreKote. The first was stripped and evaluated for corrosion and was processed through PDM with no unusual corrosion found

- Aircraft: Boeing E-3
- Aircraft Tail # 80-0137
- Surface Pretreatment: PreKote
- Akzo Nobel Paint and Primer System
  - PPG Polysulfide Spray-able Sealant PR-1436G (Upper Wing Surface)

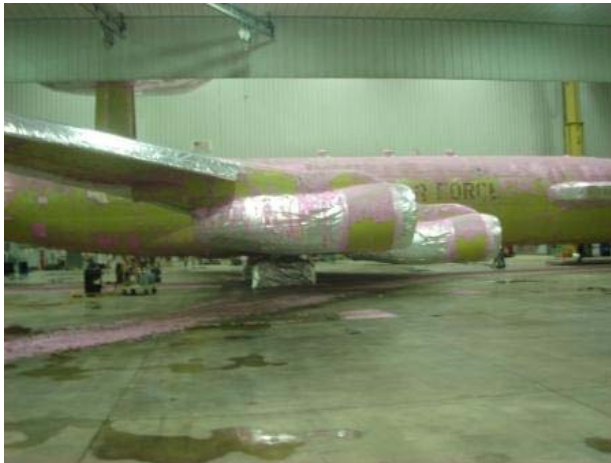
- Notes from application:
  - The first application of Dekote-AF began at 4:00am and was completed at 5:45 am
  - Temperature 73degrees / 202 gallons used of DeKote-AF

Image 1: First application stripper topcoat & surfacer primer popping off to primer

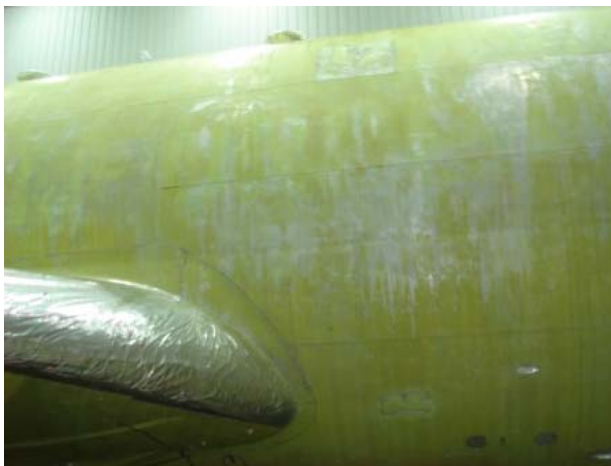
- The first water rinse was completed at 8:00am utilizing standard hose
  - After visual inspection it was noted that 95% of the top coat was removed and there were some areas of exposed skin where the DeKote-AF had removed all of the coating

Image 2: After first rinse spots of bare aluminum

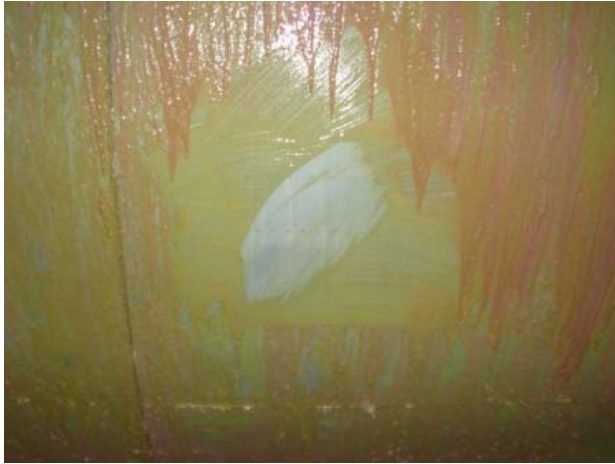
- Second application of DeKote-AF started at 9:35am and was completed at 11:00am
  - Temperature 85degrees / 175.36 gallons used of DeKote-AF
  - Visual inspection at 12:00pm primer showed signs of release from the OML of the aircraft

Image 3: 12:00pm inspection release of primer is noted waited until 2:30 for pressure rinse

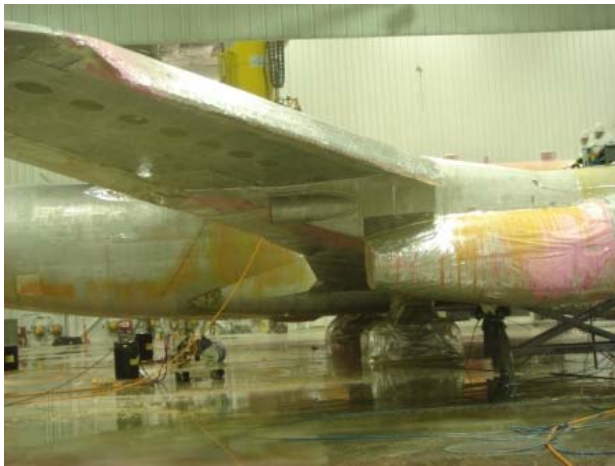
- Second rinse started at 2:30pm with a power pressure sprayer with the primer being removed very easily 160degrees at 1800PSI
  - After visual inspection 98% of all paint systems were removed including the PPG polysulfide spray-able sealant PR-1436 on upper wing surface

Image 4: Second rinse using power washer with easy removal of primer

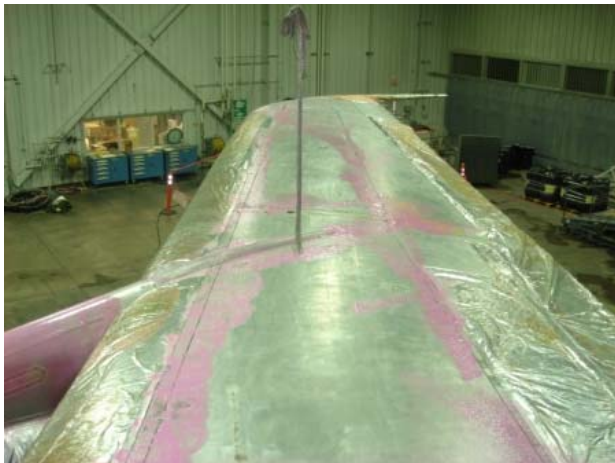
- Third application of DeKote-AF started at 5:30pm and completed at 6:30pm (this application was performed for a spot and touch up)
  - Temperature 83degrees / 90.13 gallons used of DeKote-AF

Image 5: Final touch-up strip application of DeKote AF

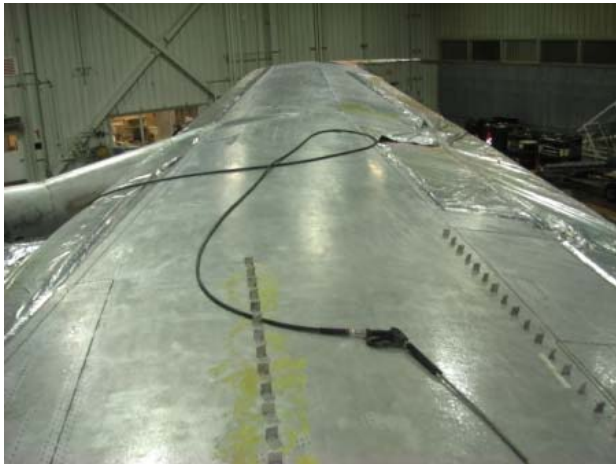
- Post Strip inspection of aircraft showed no areas of corrosion or areas of concern and a very clean strip of all coating materials and/or paint.
- The use of PreKote on Aircraft would no longer be impeded by the stripping phase of operations at Air Force Bases with the use of DeKote-AF. The use of both of these products would decrease painting and stripping production of aircraft with the added benefits that both products bring in cost savings, applications time reduction, along with corrosion protection and paint adhesion enhancement.

Image 6: Final rinse inspection wing

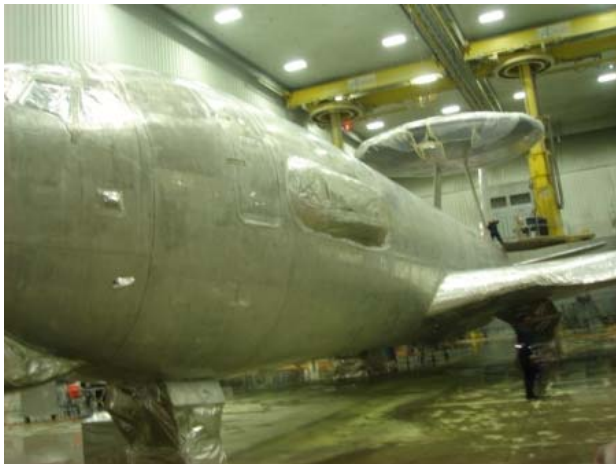
Image 7: Final rinse inspection fuselage

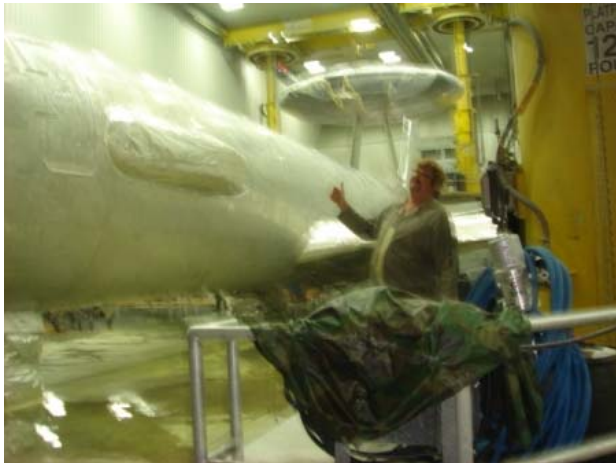
Image 8: Worker final inspection of rinse

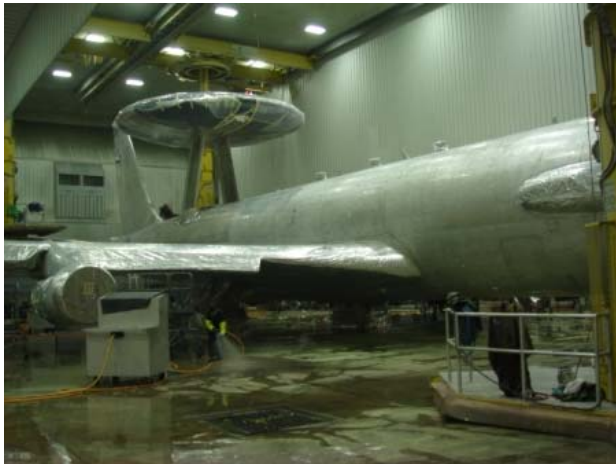
Image 9: Final inspection of fuselage
